# FINAL REPORT TO CONGRESS

THE STREAMBANK EROSION CONTROL  
EVALUATION AND DEMONSTRATION ACT OF 1974  
SECTION 32, PUBLIC LAW 93-251

REPORT EXCERPTS - NEW ENGLAND DIVISION PROJECTS

CONNECTICUT RIVER AT HAVERHILL, NEW HAMPSHIRE  
DEMONSTRATION PROJECT PERFORMANCE REPORT

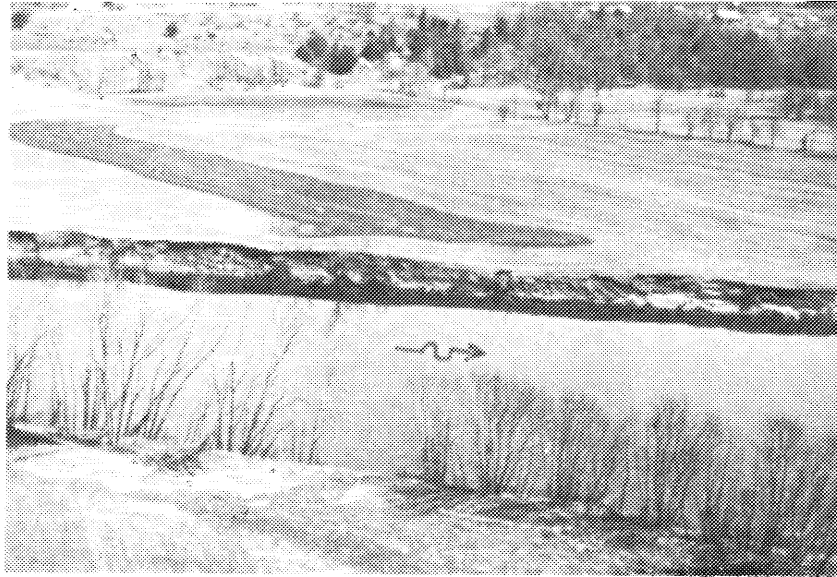
e. Channel Conditions. Under normal to moderate flow conditions the Connecticut River passes through the well defined channel it has cut through the valley floor alluvium (Plate 1 and Photo 1). The river takes a meandering course and, typically, is continually eroding its banks which are generally steep and caving and consist mainly of silty sands and sandy silts. Overtopping of the riverbank can occur whenever flows are in the order of 40,000 cfs, or on the average about every 3 to 5 years. At this particular site, high flows have passed over the top of bank, run down through an adjacent hayfield and re-joined the river at the next channel bend. The river is attempting to cut an oxbow which would create an island of about 30 acres of farmland.

PHOTO 1  
AERIAL VIEW FROM WEST  
APRIL 1978

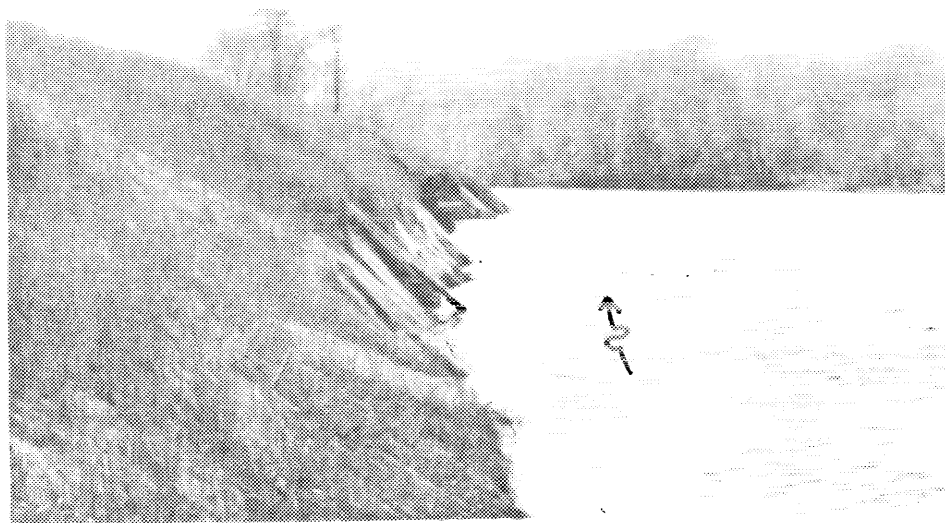
a. Lower Bank Protection. Toe protection is an essential ingredient of any successful streambank protection. This is evidenced by the failure of Reach 5, which was the only one constructed without toe protection. Stone fill should be used in rubber tire mattress instead of random earth filling. This conclusion is based on the superior performance of Reach 2A. No performance difference was observed between reaches with and without filter cloth. Noncorrodable banding should be utilized in rubber tire mattresses. Additionally, a method for controlled conveyance of overland surface runoff to the river should be provided.

PHOTO 12  
REACH 5  
MAY 1980

13. Rehabilitation. No rehabilitation has taken place at the project. However, plans and specifications are being developed which include the use of 12-inch thick gabion mattresses to provide lower bank protection in Reach 5 (no toe protection), which has failed. Repair

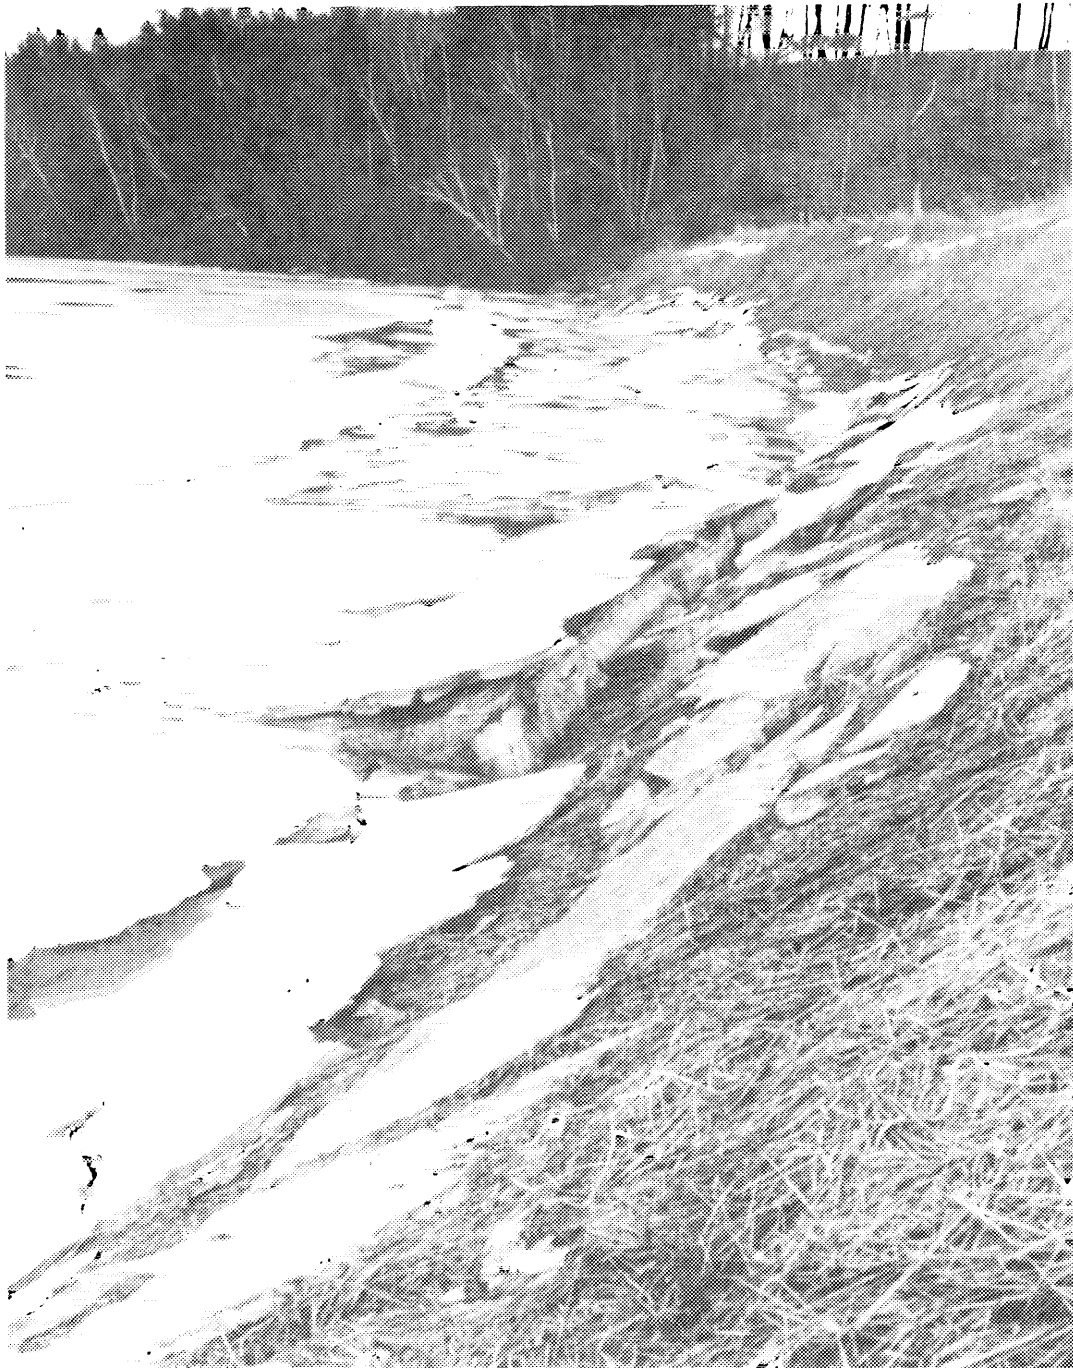
PHOTO 13

ICE CONDITIONS  
20 FEBRUARY 1981  
VIEW LOOKING UPSTREAM

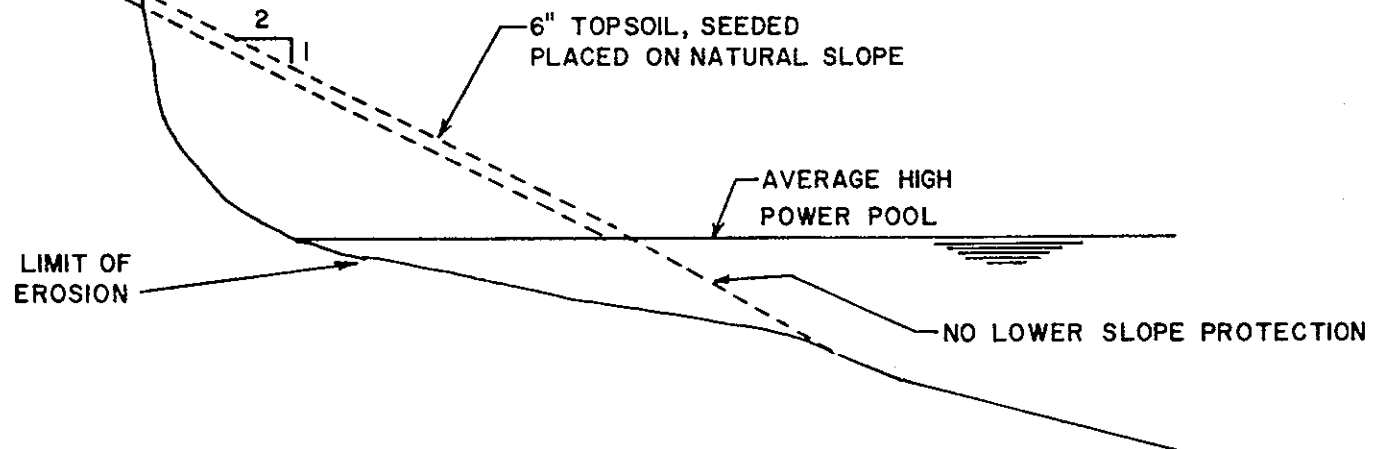
CONNECTICUT RIVER  
HAVERHILL, NEW HAMPSHIRE  
FAILURE OF REACH 5

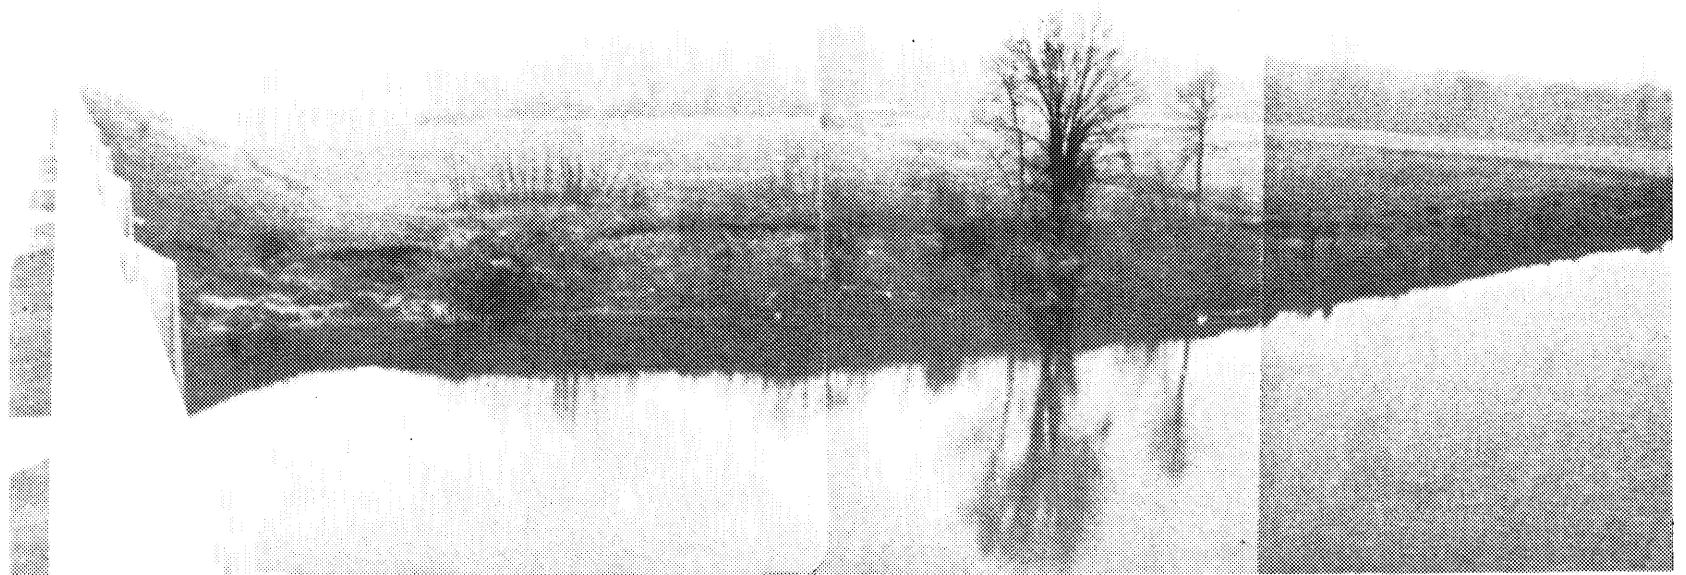
(3) Erosion Conditions. Thirteen sites along the banks of the Connecticut River in the pool behind Turners Falls Dam (river miles 122 to 142) are eroding. Although rates of erosion have not been determined at the other locations, the Northfield site is eroding at about 1 to 3 feet per year. Most of the sites are subject to the sloughing type of erosion; a lesser number are subject to mass wasting, headcutting and shallow washing. The principal cause is shear stress associated with high streamflow. Other causes such as pool fluctuation, boat waves, overbank drainage, and seepage play lesser roles in the overall erosion process. Erosion prior to construction of the demonstration project is shown in Photo 1.

PHOTO 1  
FLOW FROM LEFT TO RIGHT  
NOVEMBER 1976

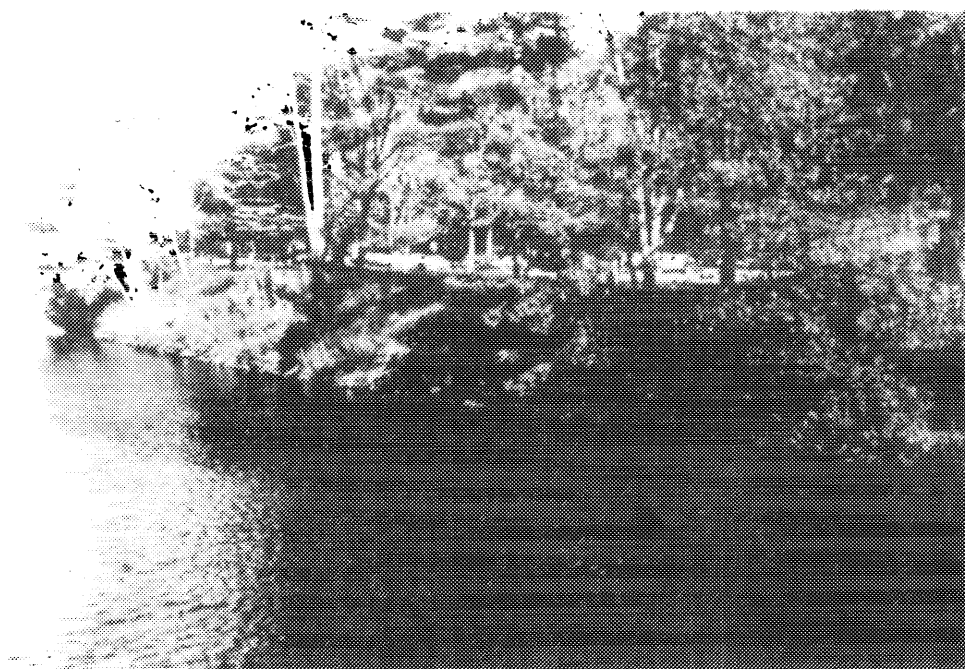
View of riprap 26 years after construction on Connecticut River at Hanover, N. H.

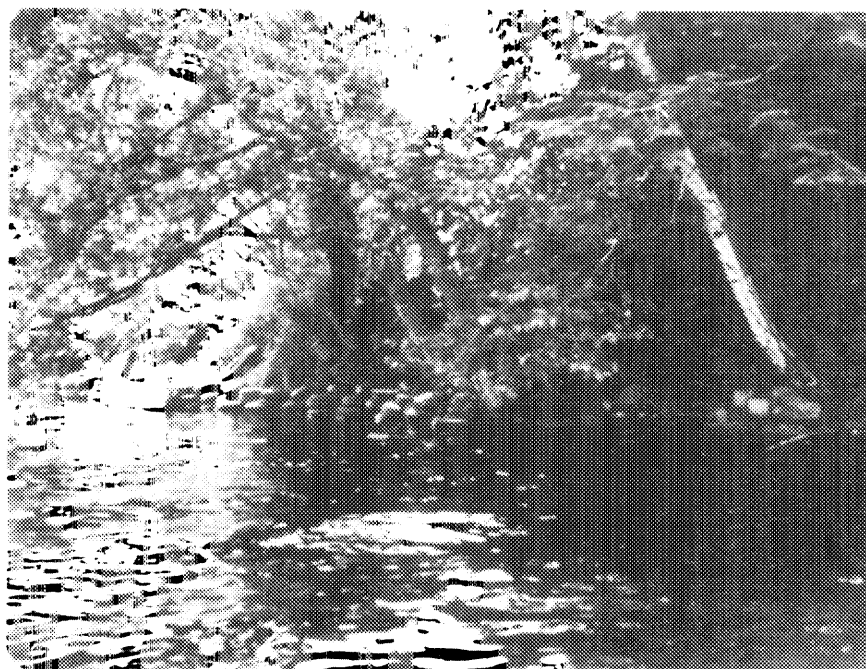
At the time of the inspection visit, vegetation had become well established above the revetment, Connecticut River at Thetford, Vt. View is downstream (26 July 1978)

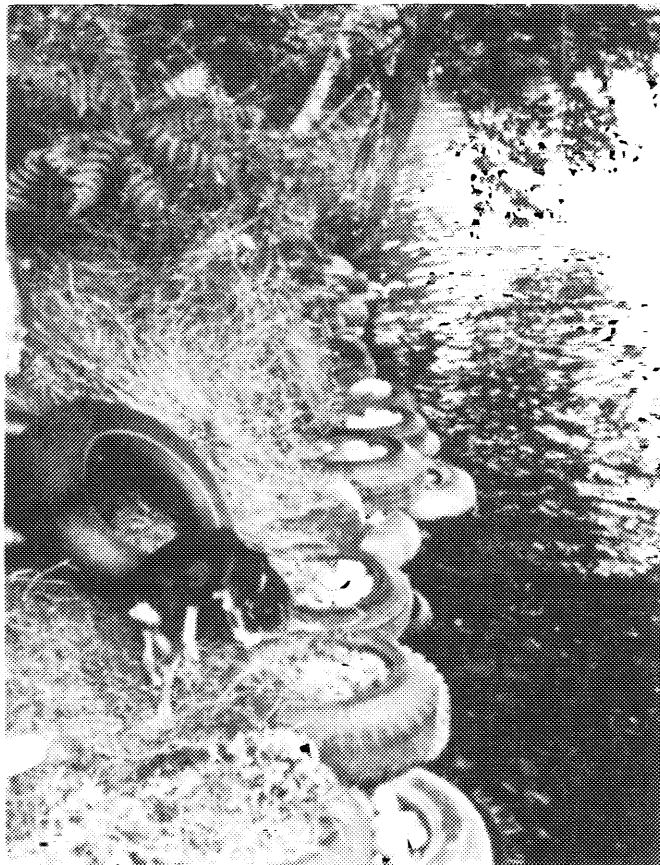
The majority of the used automobile tires have remained in place, although minor realignment has been required, Connecticut River at Thetford, Vt. View is upstream  
(26 July 1978)

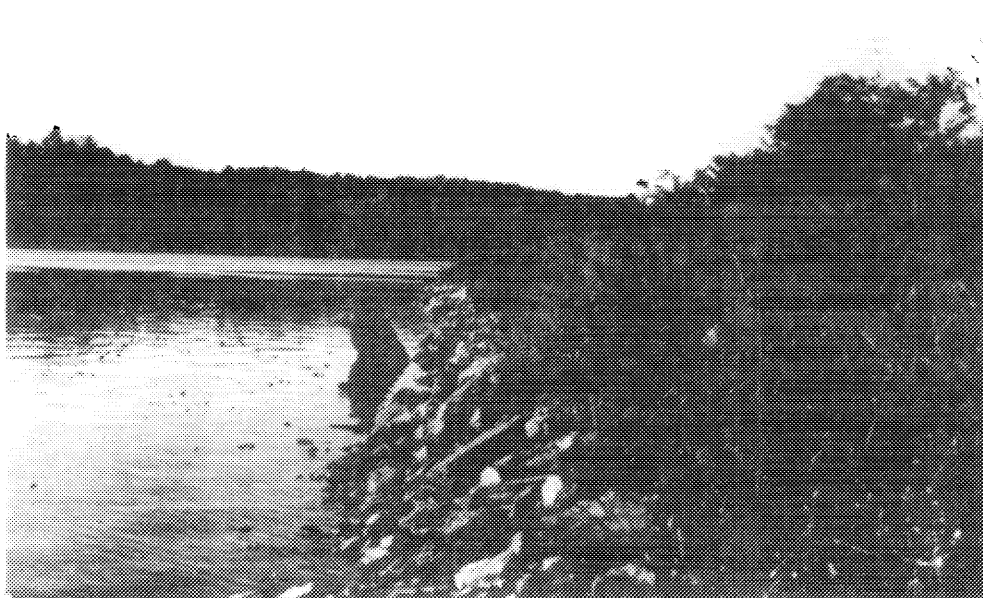
Three years after placing riprap and hydroseeding at Stacy's Ferry, Connecticut River at Turner's Falls Pool (Oct 1980)

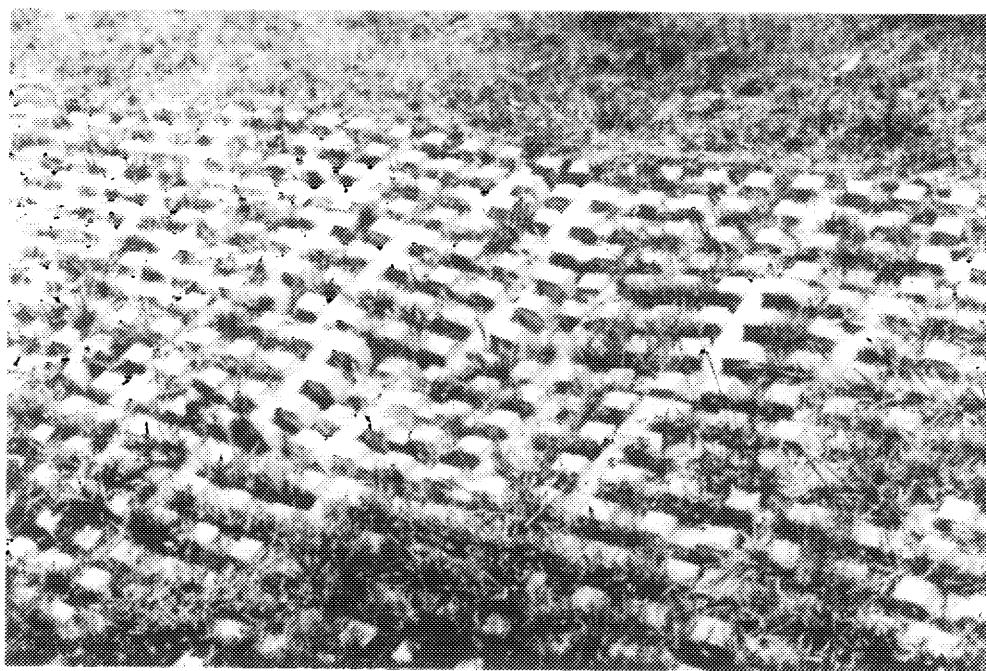
Settlement of upper right slope at Sta 3+50
